# ACF200 Stub Sill Underframe

## MAINTENANCE BULLETIN

November 18, 2020

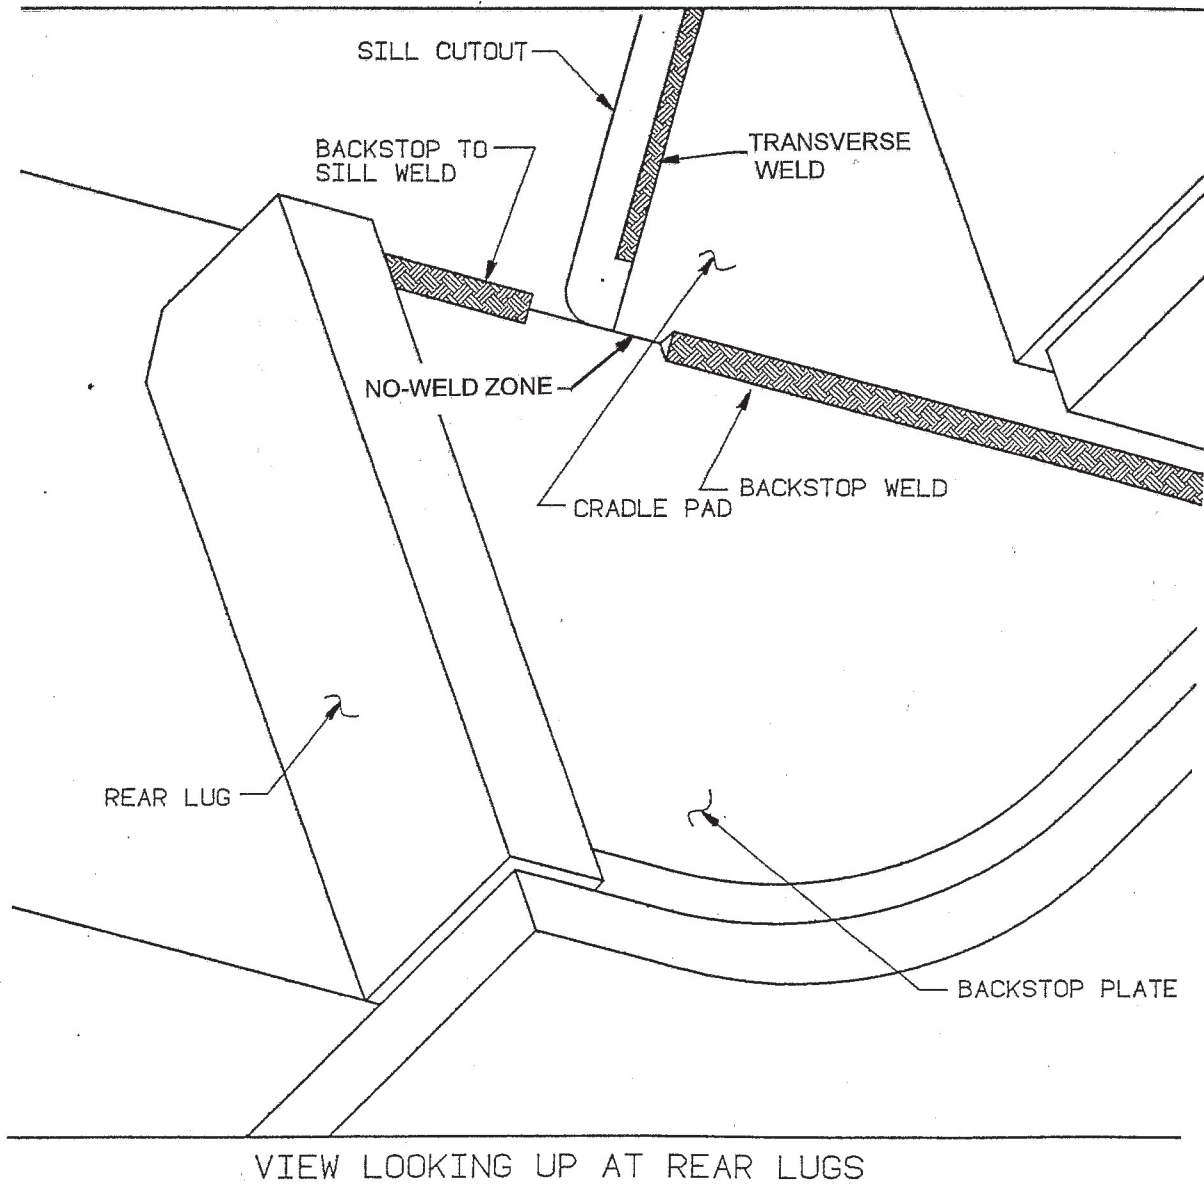
**FIGURE 2**  
OVERVIEW OF TRANSVERSE AND BACKSTOP WELD AREA

Inspect the transverse weld for defects. If 5" of sound weld remains after all defects are removed and no other repairs that require stress relief in the area are necessary, then replacement of the transverse weld is not required. If stress relief is required or less than 5" of sound weld remains, then replace the 7" transverse cradle pad to tank weld (reference Figure 2) per Appendix A, attached.

- A. Inspect the backstop area for buckled rear lugs and repair as required. No repairs are required if no defects are found.
- B. If defective welds are found, then gouge or grind the backstop weld to form a 1" no-weld zone from the outboard edge of the cradle pad.

Note: If the existing backstop weld is a sound fillet weld and no defects exist, then no further repairs are required. Thoroughly inspect the cradle pad parent metal for cracks, dye check as required. If any cradle pad parent metal cracks are found, then repair per Appendix B, before continuing. Build-up any gouged areas of the backstop plate or cradle pad with AWS E-7018 or E71T-1, grind smooth, and proceed to step 6,G.

- C. If areas of the weld are defective, then form a welding groove as follows:
  - 1. Gouge out all defective areas to form a 3/8" deep continuous groove for welding, one on each side, minimum 6" length.

- 1. Preheat area to 200°F minimum and weld using AWS E-7018 or E71T-1.
  - 2. In the groove gouged in step 6, C, above, apply a 3/8" bevel weld with a 1/2" oversized fillet weld starting 1" from the edge of the cradle pad and extending inboard for the 6".

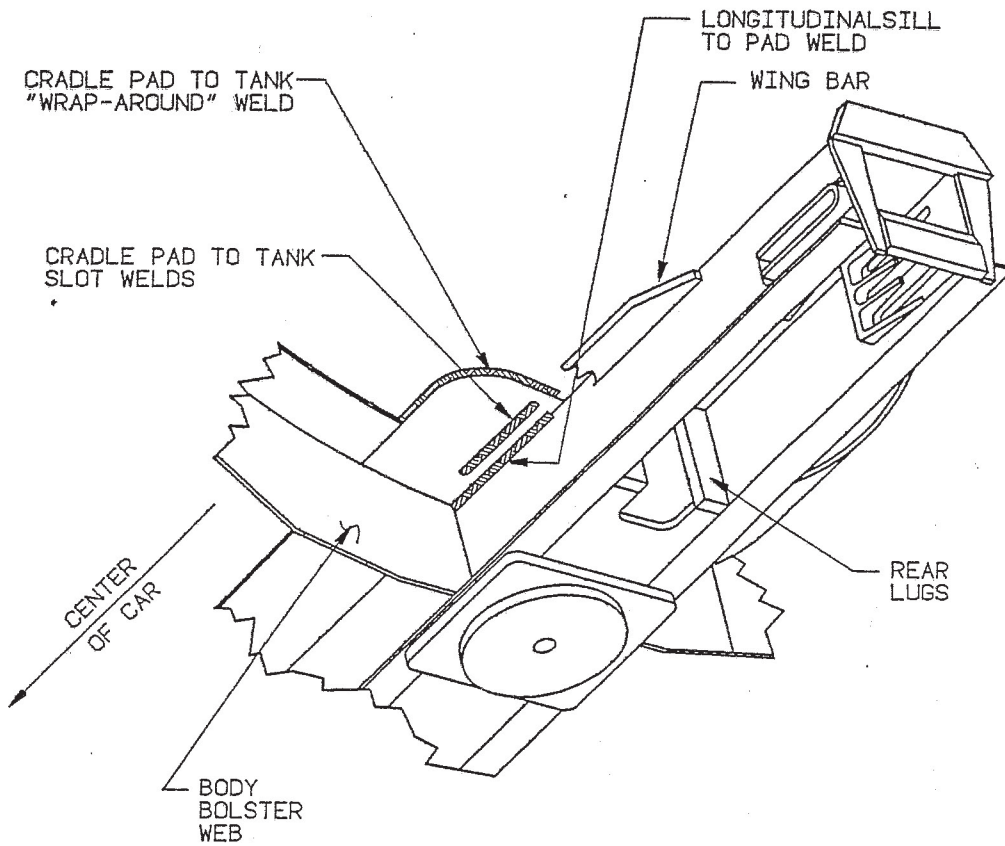
**FIGURE 3**  
OVERVIEW OF "LONGITUDINAL" WELD AREA

Inspect the cradle pad to tank shell "wrap around" welds, reference Figure 3, and remove the stick weld portion of this weld (if present). The existing stick weld may remain if it is a full 7/16" fillet weld with a good quality termination and the toe of the weld along the tank is of good quality. Undercutting and cold lap is not acceptable along the tank shell or at the cradle pad. This repair must be symmetric about the longitudinal centerline of the car.

Inspect the end of the longitudinal weld for a 1" no-weld zone (NWZ) at the outboard end of the cradle pad. No repairs are required if no defects are found. If defects in the weld or parent metal are found, then repair as follows:

- A. Using a small diameter carbon arc rod, gouge the longitudinal weld attaching the cradle pad to draft sill to create a 1" (NWZ) from the outboard edge of the cradle pad. The weld attaching the cradle pad to sill must be removed in the 1" NWZ. This is to be accomplished by removing sill metal as required, not the cradle pad parent material.

1. The minimum weld length is 2" (reference step 5,A above), so that a 1" backweld can be achieved on both ends.
2. Preheat area to 200°F minimum.
3. Apply a combination J-groove weld and 1/2" fillet weld using AWS E-7018 electrode, or E71T-1 (if clearance is adequate). After repairing the original defective weld, oversize the longitudinal weld size to a 1/2" fillet for a 6" length. Start at the 1" NWZ from the edge of the cradle pad and extend the 1/2" fillet weld inboard for 6".

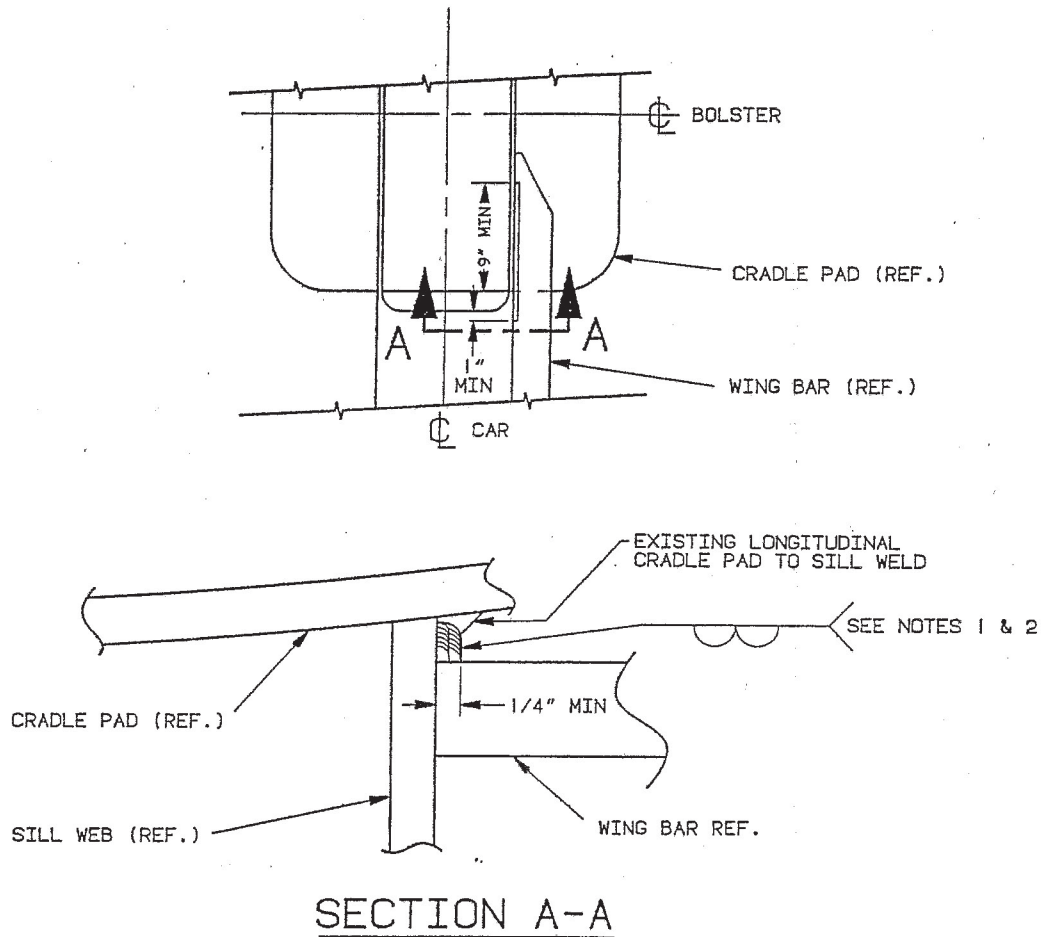
**FIGURE 4**

- F. If sill defects exist or the wing bar was removed, then build-up section of sill web above the wing bar per Figure 4.

1. Preheat area to 200°F minimum and build-up sill web with AWS E-7018 electrode or E71T-1 (if clearance is adequate).
2. Built-up section of the web should extend outboard past the cutout in the sill top flange by 1" minimum, and 9" inboard from the edge of the cradle pad.
3. Built-up contour should add 1/4" of thickness to the sill web and be relatively flat, that is, use approximately a one-half weld lap as opposed to a one-third weld lap. Finished weld will be approximately 2 layers of a 3-6 pass weld.
4. Care must be taken to ensure a smooth transition where the weld build-up meets the existing longitudinal weld termination.

1. ELECTRODE: AWS E-7018 OR AWS E71T-1
2. FINISHED WELD TO BE 1/4" THICKNESS (2 LAYERS OF OF 3-6 PASSES-APPROX.). LAST LAYER TO BE HALF-WELD BEAD LAP.
3. CARE MUST BE TAKEN TO TIE THE TERMINATION OF THE EXISTING LONGITUDINAL WELD INTO THE SILL BUILD UP.

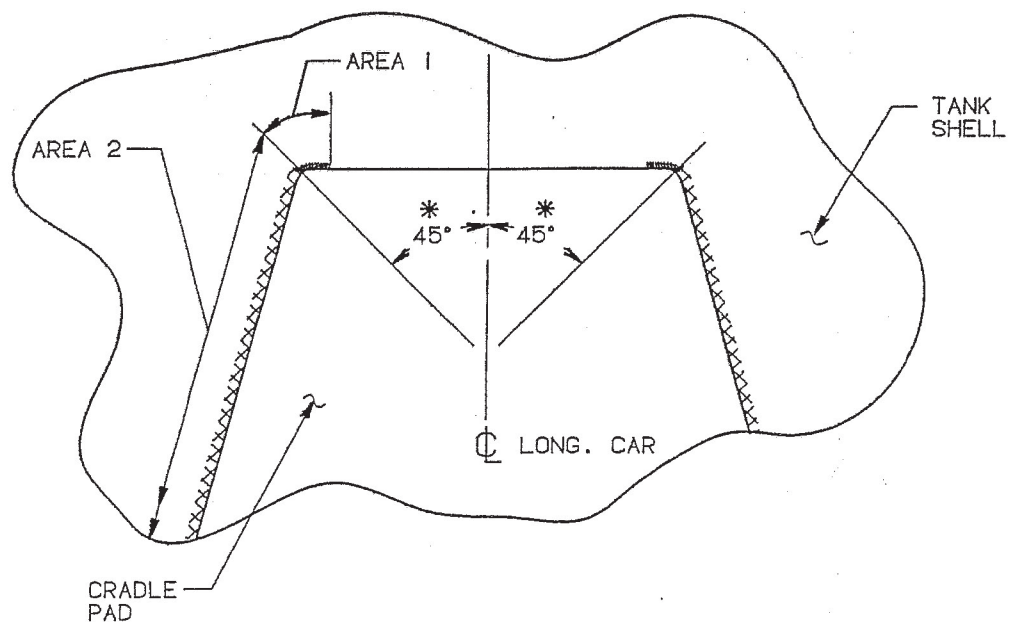
**FIGURE 5**  
INBOARD CRADLE PAD TERMINATION DETAIL

Inspect the inboard termination of the cradle pad. Repair any weld cracks found per Figure 5.

- A. If a crack exists in Area 1 (Figure 5), then remove the crack by gouging and/or grinding the existing weld to the 45° line. Weld repair is not required.
- B. If a crack extends into Area 2 (Figure 5), then in accordance with Appendix R and W repair the weld. The repair weld should not extend beyond the 45° line as shown in Figure 5.

- AREA 1
- A. GRIND OR ARC-GOUGE AND GRIND TO REMOVE BOTH CRACKED AND SOUND SOUND WELD METAL TO THE 45° LINE AS SHOWN.
  - B. GRIND CRADLE PAD AND TANK SHELL SMOOTH, AND GRIND A SMOOTH TERMINATION ON THE WELD.
  - C. DYE CHECK TANK SHELL AND 1" OF THE REMAINING WELD.
  - D. REMOVE AN EQUAL AMOUNT OF WELD FROM ADJACENT CRADLE PAD CORNER AND DYE CHECK AREA.

AREA 2 REPAIR IN ACCORDANCE WITH M-1002, APPENDIX R&W.

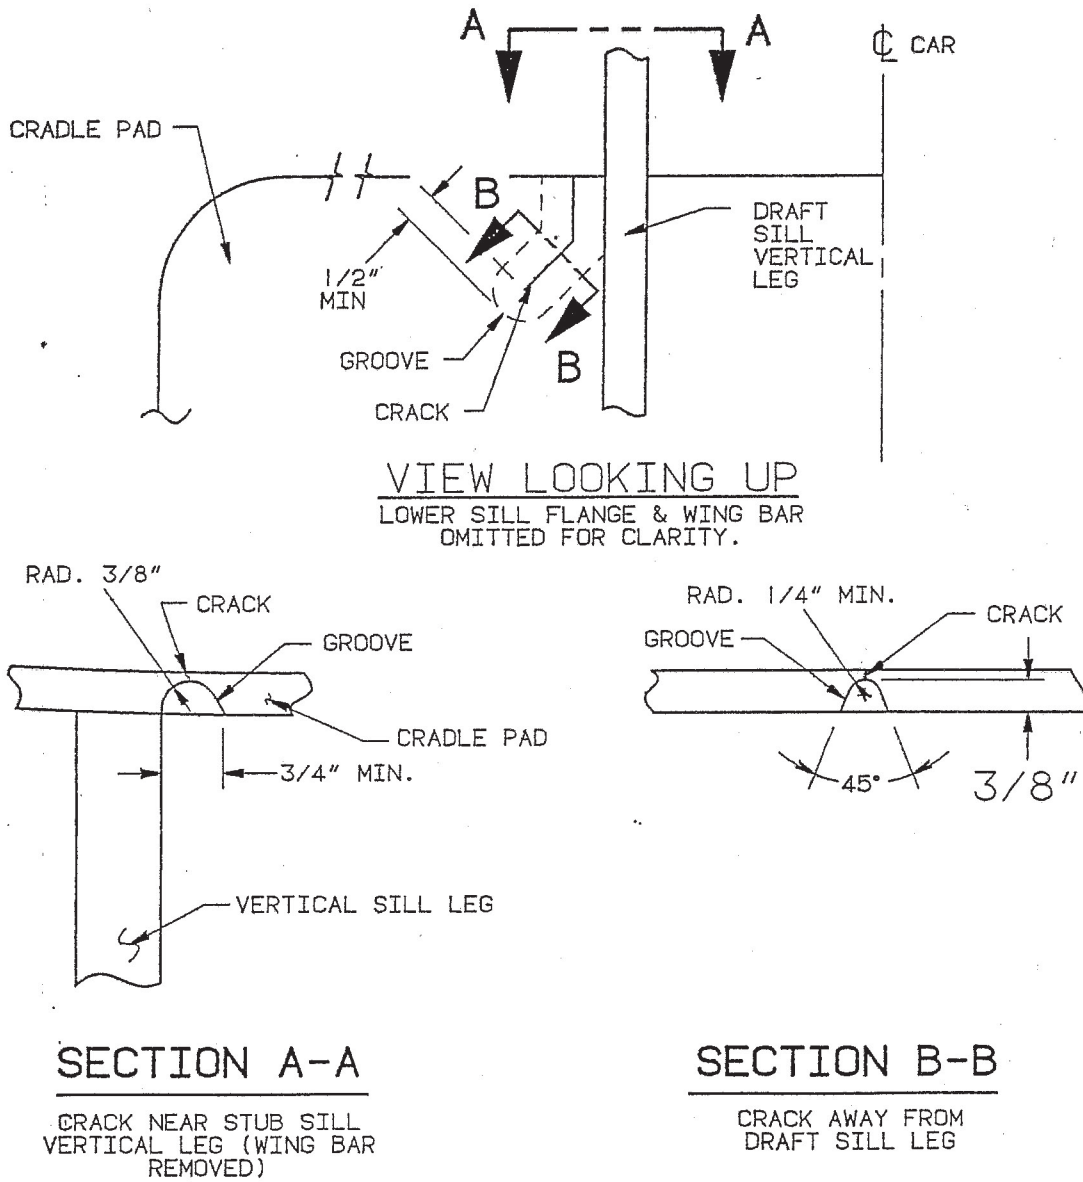
**FIGURE B-1**  
**CRADLE PAD PREPARATION**

This Appendix B details the recommended procedure for the repair of cradle pad parent metal cracks. All cradle pad parent metal cracks **must** be repaired.

3. Form a groove 3/8" deep maximum, per Figure B-1 of this appendix. Groove should extend past end of fracture by 1/2" minimum and be ground to have a smooth contour for subsequent dye check and welding.
4. Dye check to ensure the end of the fracture has been completely removed.
5. Remove dye check and preheat the cradle pad to 200°F minimum prior to welding.
6. Repair weld the groove with AWS E-7018 or E71T-1 electrode using good, sound welding practice, being careful not to burn through to tank. A runoff tab may be required to prevent destroying the edge of the cradle pad.

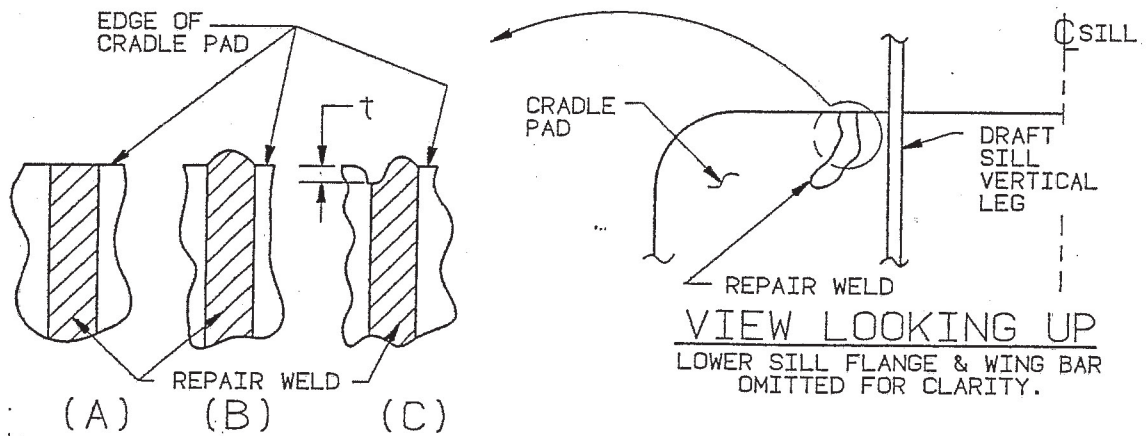
**FIGURE B-3**  
CRADLE PAD EDGE CONDITION

- (A) PREFERRED
- (B) UNACCEPTABLE - GRIND TO SMOOTH TRANSITION AND REMOVE EXCESS MATERIAL.
- (C) UNACCEPTABLE - GRIND TO SMOOTH CONTOUR. MAXIMUM ALLOWABLE  $t$  IS 1/8" WITH SMOOTH CONTOUR.

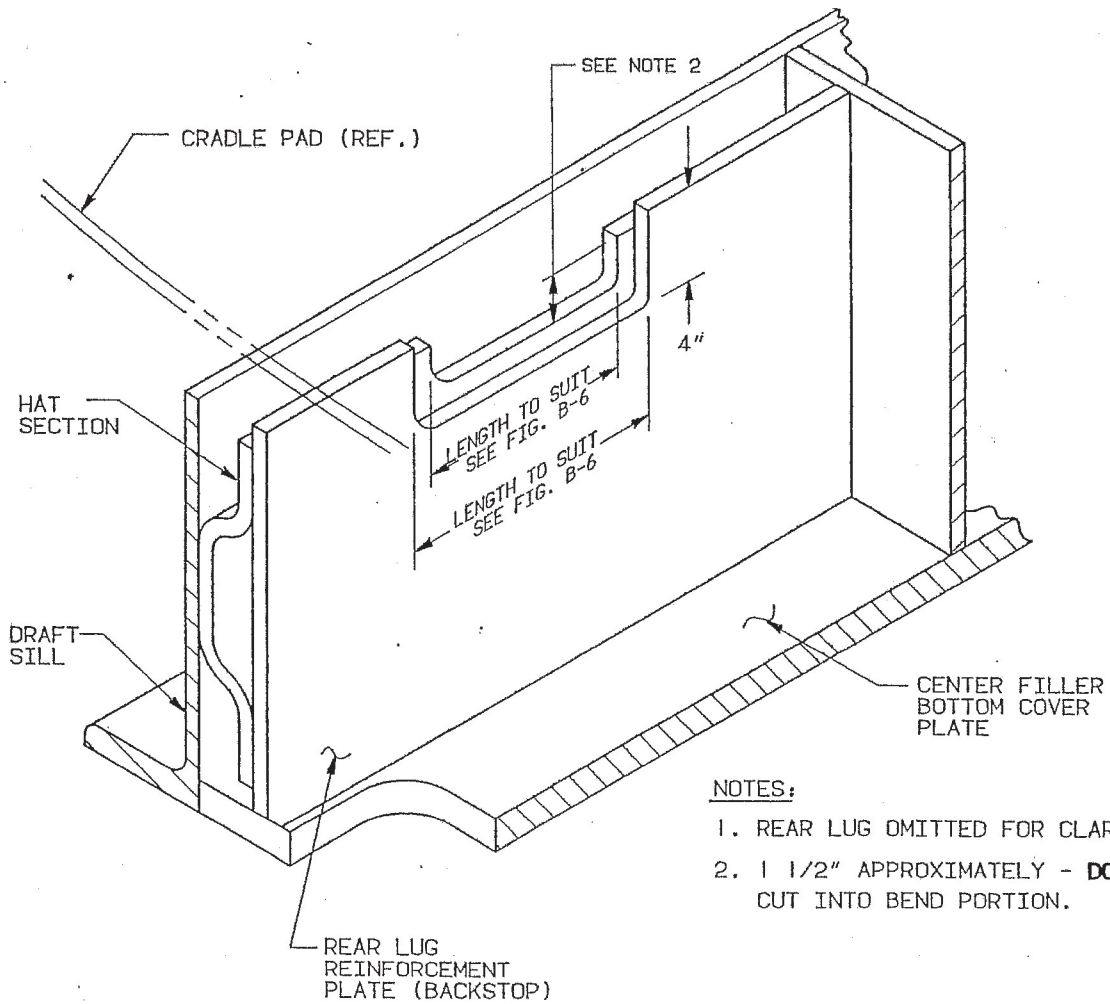
**FIGURE B-5**  
CRADLE PAD ACCESS AT REAR LUG

Note: Most cracks in the cradle pad parent metal are accessible at this point, however occasionally a crack is not accessible due to the backstop plate or the draft sill. If the crack is not accessible due to the backstop plate, it will be necessary to gain access per the procedure detailed in Section B below. If crack is not accessible due to the crack running above the sill web, it will be necessary to gain access per the procedure detailed in Section C, below.

- NOTES:
1. REAR LUG OMITTED FOR CLARITY.
  2. 1 1/2" APPROXIMATELY - **DO NOT** CUT INTO BEND PORTION.
