Side Sill Closure

INSPECTION AND REPAIR BULLETIN

October 7, 2020

This Inspection Bulletin provides details for the inspection and modification of side sill closure plates on ACF built Center Flow® covered hopper cars. The closure plate may be referred to as the pistol plate, or hair pin closure.

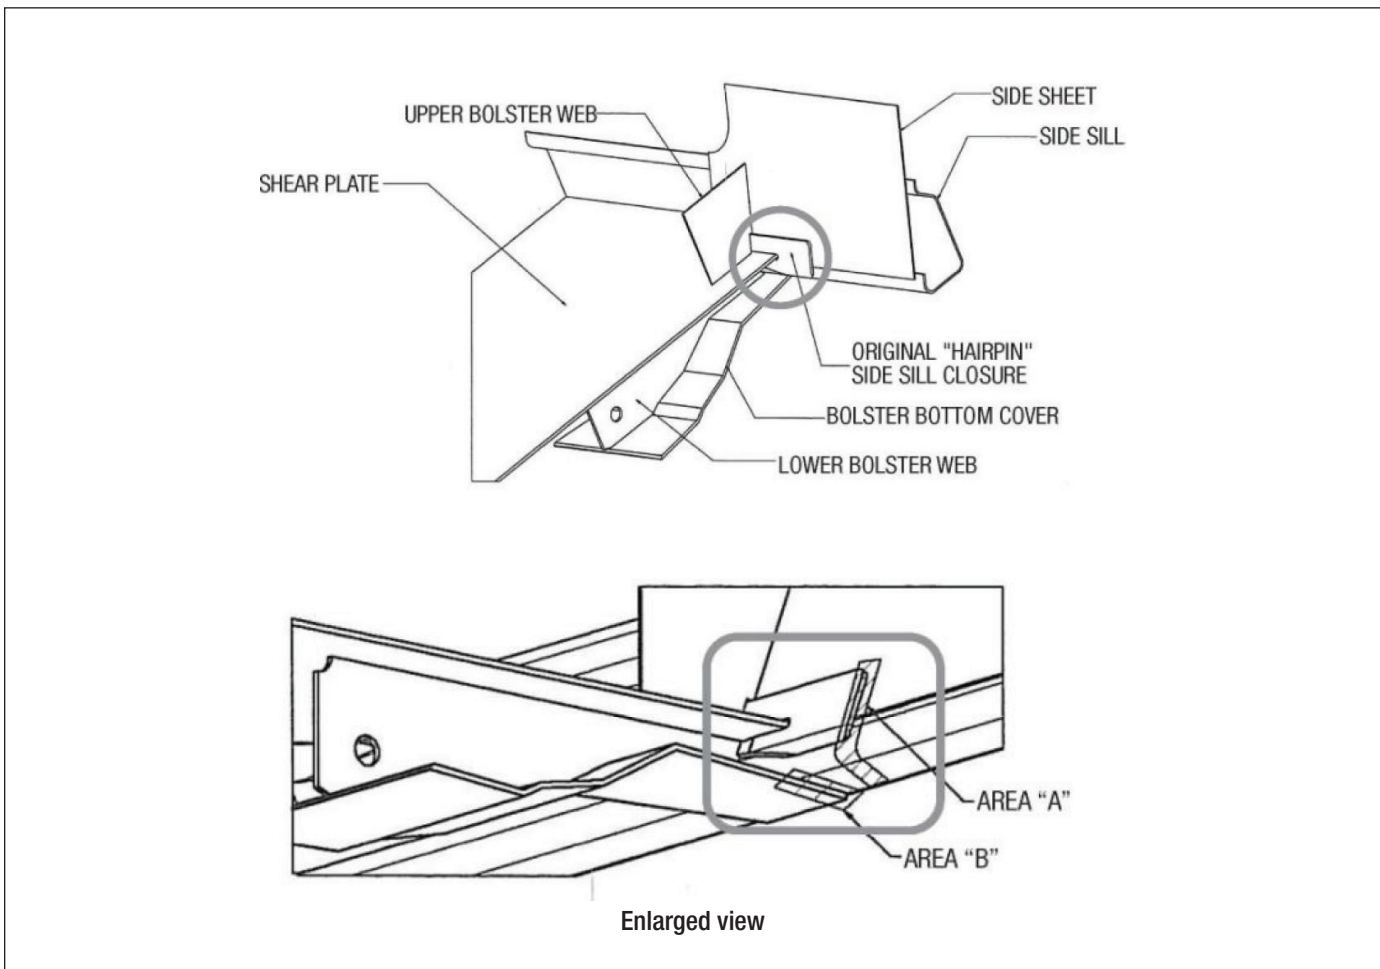
The side sill closure plate was utilized from 1978 – 2005. The areas shown below should be inspected for discontinuities in the form of cracks emanating from the welds at the inboard end of the closure plate attachment to the side sheet and at the bolster bottom cover attachment to the side sill. In all cases, replacement with a new closure plate is recommended at all four corners.

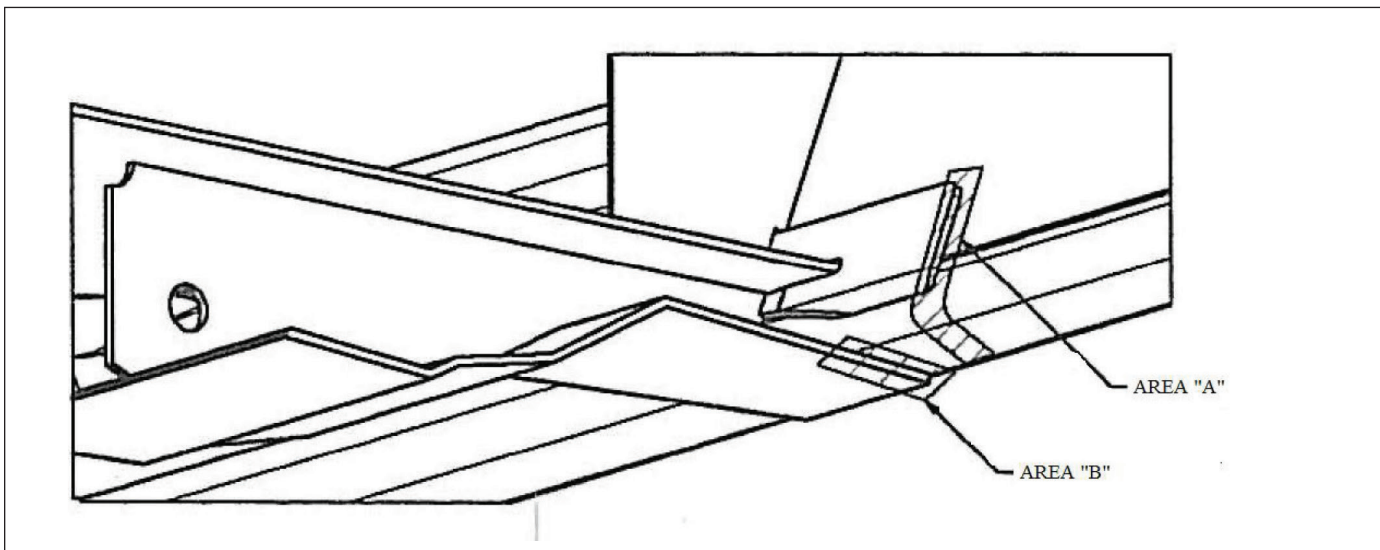
Inspection & Repair of Inboard Weld Termination

Cracks emanating from the welds can propagate up into the side sheet and down to the inside radius of the side sill and outward along the bottom of the side sill.

- Remove all dirt and debris from Areas "A" and "B" by wire brushing.
- Dye penetrate inspect these areas.
- If no cracking is found proceed with replacement of the side sill closure plate (recommended), or return the car to service. If the car is returned to service without replacement of the closure plate a plan should be implemented to inspect this area on a routine basis.

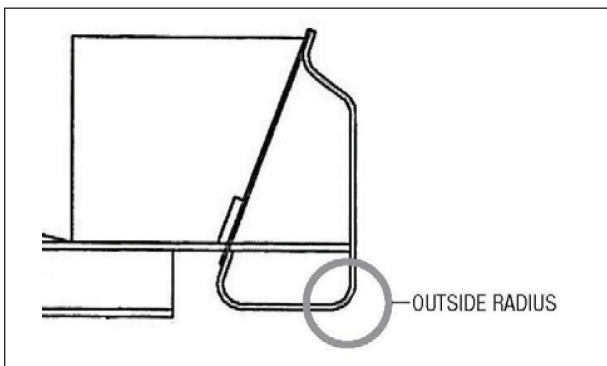
Critical Note: If any of the following special conditions are observed it will be necessary to replace a section of the side sill. See "Side Sill Section Replacement."

- A crack that splits and branches in multiple directions
- Two or more cracks within 3" of one another
- A crack that propagates into the outside radius of the side sill, see below.

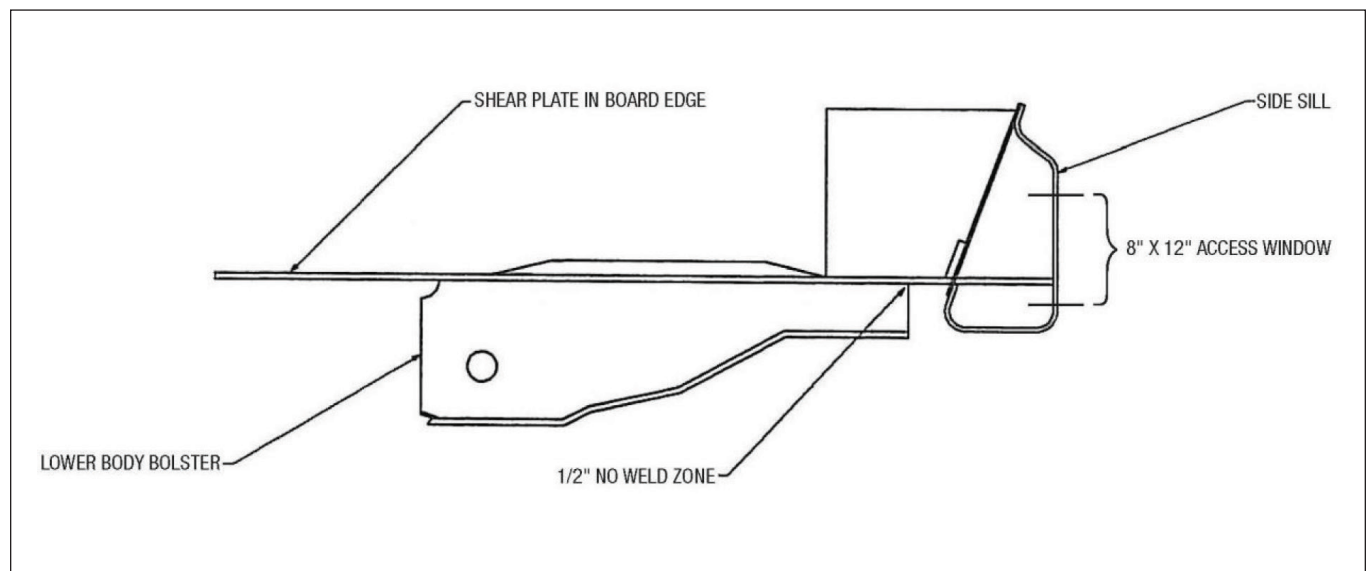
Side Sill Inspection & Repair Procedures

- With the closure plate removed, dye penetrate or magnetic particle inspect area "A."

- Side sill cracks must be repaired from both sides.
- Access to the interior of the side sill is gained by cutting a window, 8" vertical x 12" horizontal, in the outside vertical flat of the sill. Radius the corners to 2" minimum. Save the cutout scrape to seal the access window when the repair is completed.

- The outboard edge of the opening must be 1 1/2" from the inboard edge of the shear plate.
- Beginning inside the sill, remove the crack by air arcing the affected area plus 1/2" beyond the crack length to a depth of 1/4". Prepare the area for welding.

- Weld the area using E7018 electrodes or equivalent wire. Weld first pass stringer and weave the remaining passes.
- Prepare the outside surface with air arc to a depth that will ensure a 100% weld penetration in weld. Prepare the area for welding.

- Weld the area using E7018 electrodes or equivalent wire. Weld first pass stringer and weave the remaining passes.
- Close the access window by preparing the edges of the sill opening and the saved panel.

- Apply 1/8" x 2" wide backup strips inside window opening.
- Replace the panel section and weld with E7018 electrodes or equivalent wire ensuring 100% penetration.
