Tank Car Inboard Stub Sill Inspection and Modification

INSPECTION BULLETIN

October 7, 2020

Application Criteria: Tank Cars built prior to October 1, 2011 with ARI300 stub sills.

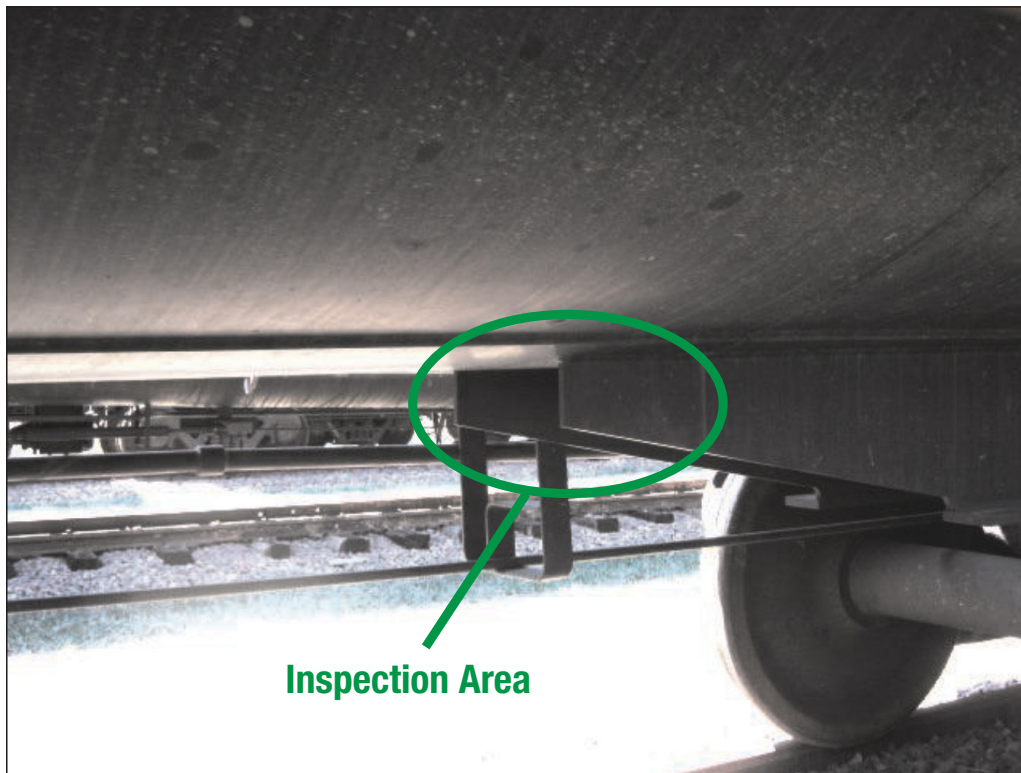
FIGURE 1

Inspect the cradle pad for any cracks at the inboard termination of the draft sill, this area is shown in Figure 1. Visual inspection can be aided with non-destructive testing as deemed necessary by the inspector. The type of modification to be performed is to be determined by the results of the inspection:

Condition 2: Cracks of any length found in cradle pad. (Modification 2)
