# ACF200 Stub Sill Underframe

## MAINTENANCE BULLETIN

November 18, 2020

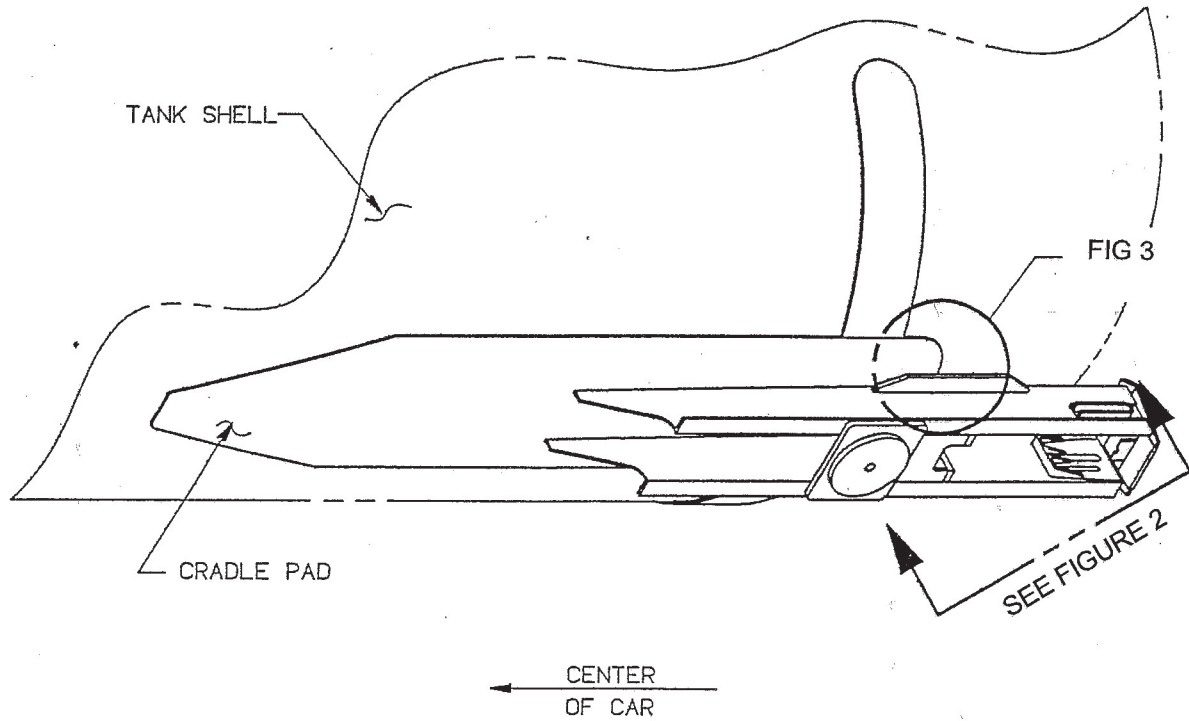
# FIGURE 1

This bulletin applies to unmodified general service tank cars that were built with an ACF200 underframe between 1969 and mid-1996 (see Figure 1). This TC200 maintenance bulletin offers inspection, repair, and enhancement of the original underframe, particularly for the following areas:

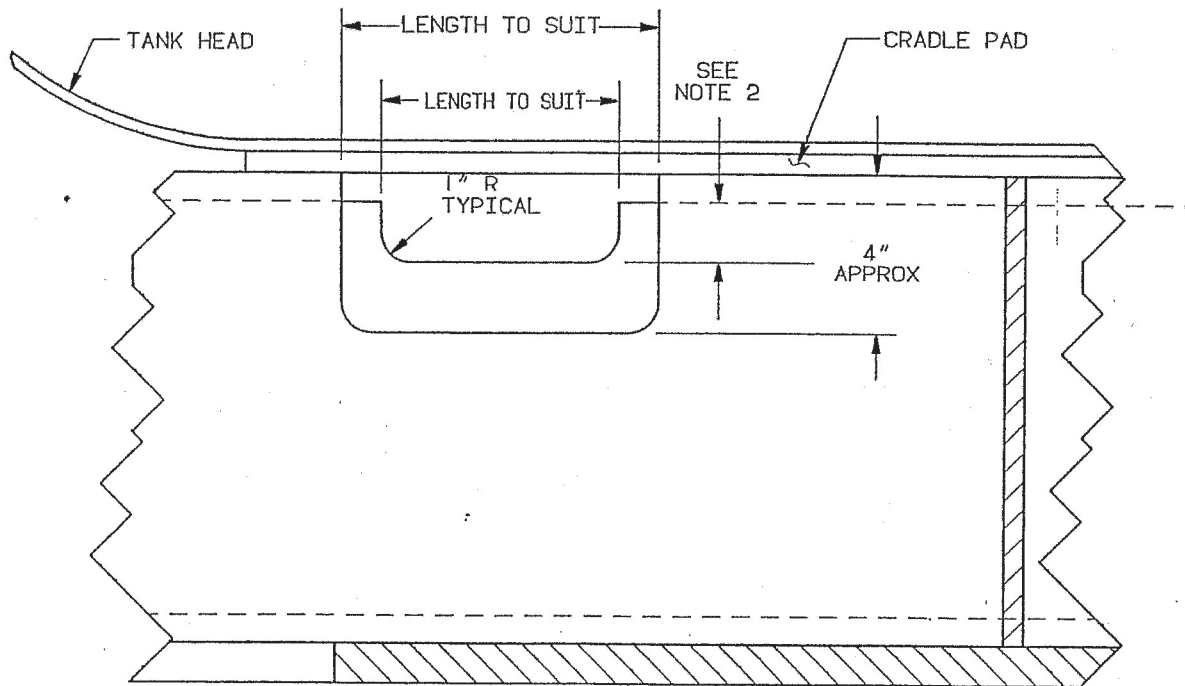
1. VERTICAL CUTS SHOULD **NOT** BE IN LINE WITH THE EDGE OF THE CRADLE PAD OR THE BACKSTOP WELD TERMINATION.
2. **DO NOT** CUT INTO THE BEND PORTION.
