Side Sill Closure

INSPECTION AND REPAIR BULLETIN

October 7, 2020

This Inspection Bulletin provides details for the inspection and modification of side sill closure plates on ACF built Center Flow® covered hopper cars. The closure plate may be referred to as the pistol plate, or hair pin closure.

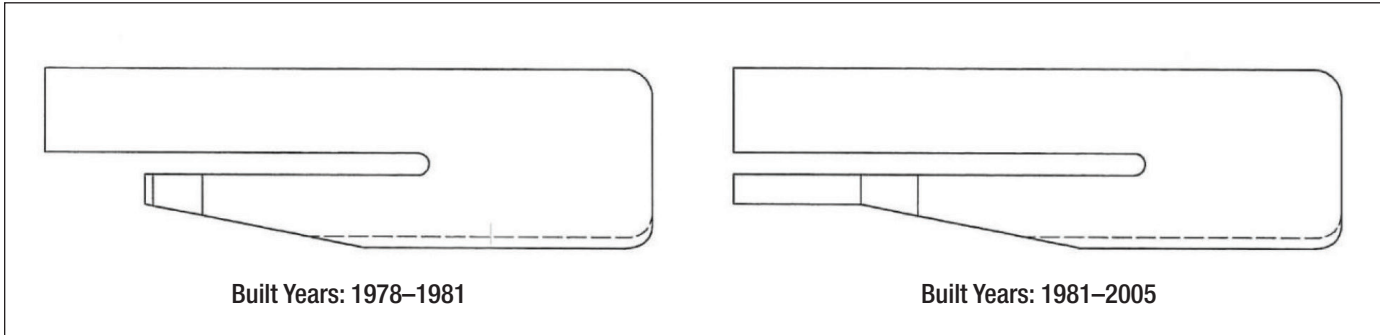
The side sill closure plate was utilized from 1978 – 2005. The areas shown below should be inspected for discontinuities in the form of cracks emanating from the welds at the inboard end of the closure plate attachment to the side sheet and at the bolster bottom cover attachment to the side sill. In all cases, replacement with a new closure plate is recommended at all four corners.
